PHOTOGRAPHIC MONITORING OF THE IONA II SHIPWRECK – AIDE MEMOIRE

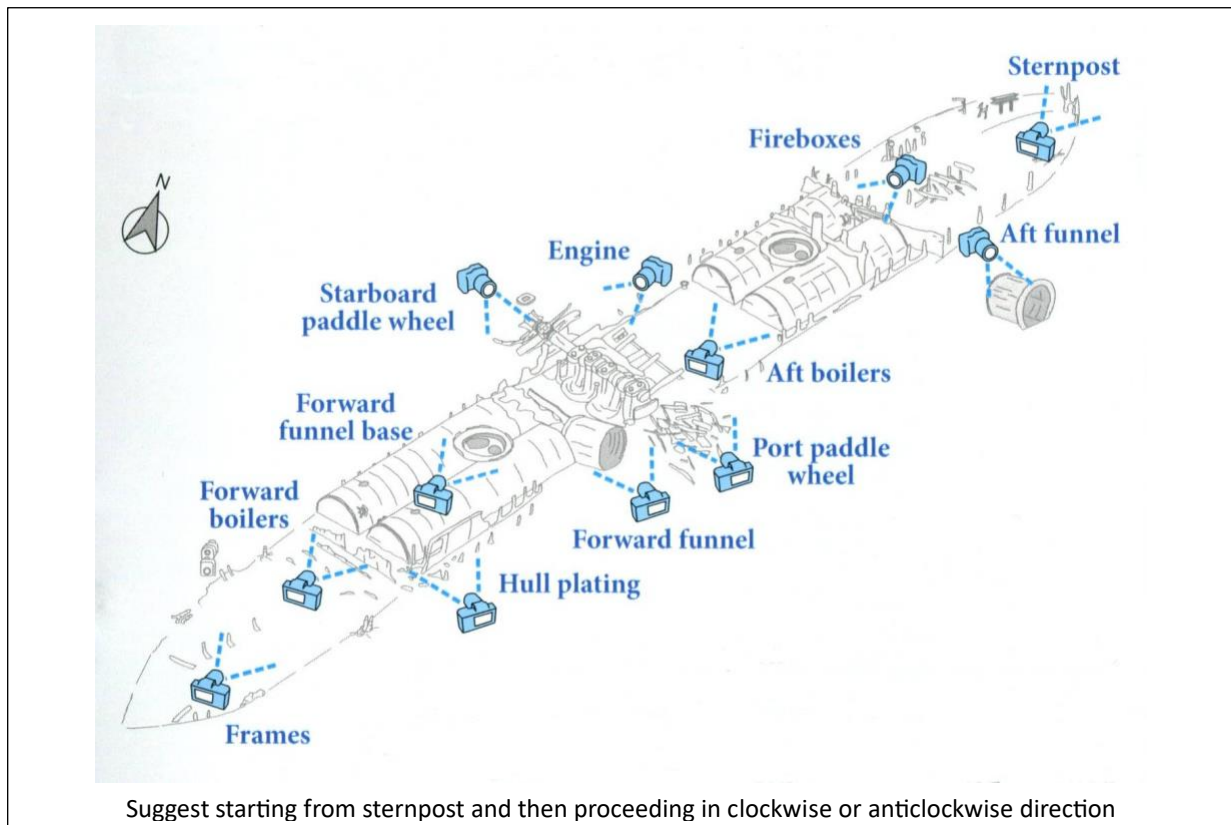
Since becoming detached from the deck and settling to the port side of the wreck, this section of funnel has remained fairly stable over the past few decades.

These shorter aft boilers are covered in a layer of concretion. The plating of the starboard boiler has corrosion holes making the silt inside visible. Piles of ballast may be visible aft of these boilers.

The crankshaft and pistons were intact when the wreck was rediscovered; however, since then various brass fittings have been removed from the machinery.

Piles of coal and a grill are occasionally visible forward of the boilers depending on the sediment levels. The bulkhead forward of these boilers has almost disintegrated.

Until about 2011 small upright sections of funnel were visible around the funnel base; however, these have since disintegrated.

The only hull plating remaining above the surface, corrosion is quite common in this area and the square hole pictured is increasing in size.

This wheel structure was intact in the 1970s with spokes still attached but no floats. By the mid 1990s it had almost disintegrated to its current state.

This paddle wheel was fairly intact when the wreck was rediscovered. It collapsed in 1990 with further disintegration taking place over the following years.

The sternpost area has remained fairly stable since the wreck was discovered in 1976. However, in 2011 a curved metal bracket was bent around the upright section and then lost.
